**CITY OF STORM LAKE  
REGULAR COUNCIL MEETING, CITY HALL  
COUNCIL CHAMBERS  
MARCH 2, 2020  
5:00 PM**

- 8. **Public Hearing for Submission of an Application for a Community Development Block Grant - Memorial Lift Station**
- 9. **Resolution No. 55-R-2019-2020 Committing Matching Funds for a Community Development Block Grant - Memorial Lift Station**

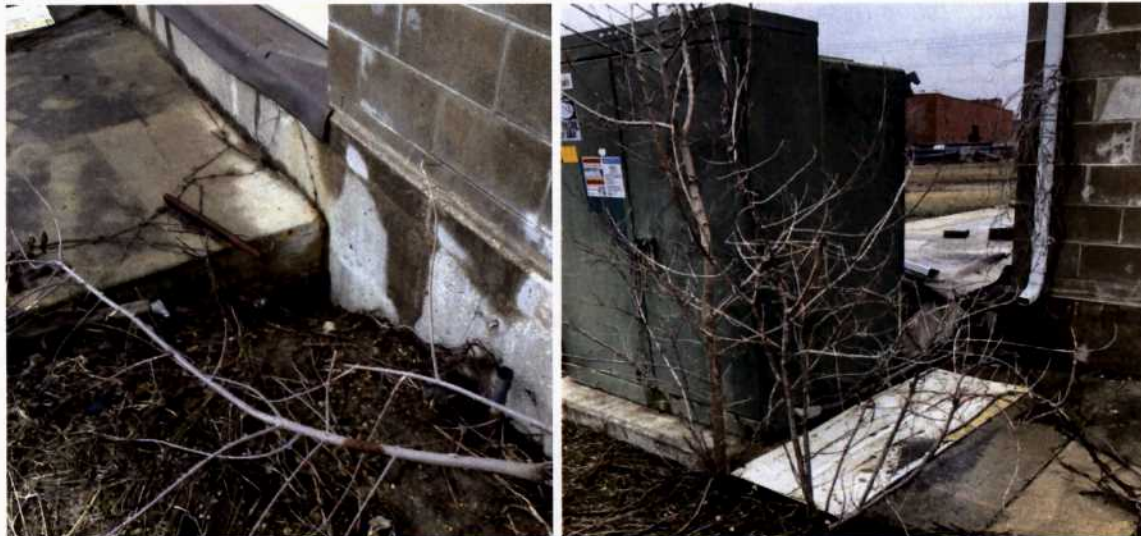
Around the exterior of the lift station, animals have burrowed holes at several locations below stoops and the transformer pad. These holes should be filled and measures taken to prevent future unwanted excavations. Vegetation has grown up around the building slab as well, hindering maintenance access. The roof gutter downspouts are not connected to a sufficient outlet and several of them discharge directly to the ground immediately next to the lift station. This likely contributes to water accumulation and seepage into the lift station. For proper drainage, the downspouts should be directed further away from the building exterior.

*Figure 2: Animal Burrows, downspouts, and vegetation around lift station exterior*

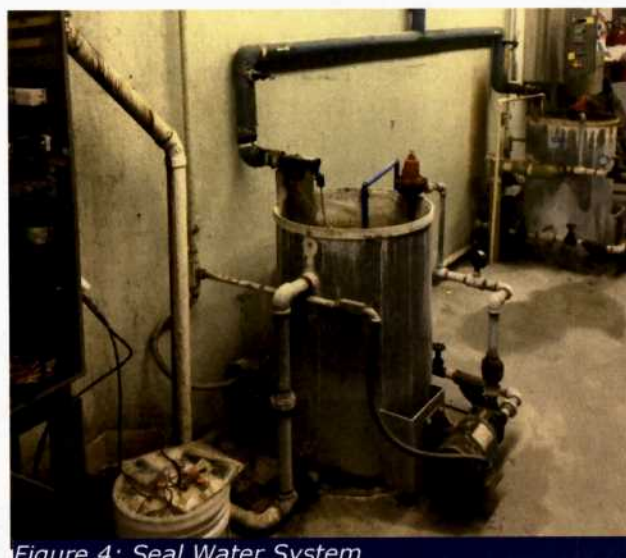
The seal on Pump #2 was recently replaced with a new mechanical seal as well. While not required, the manufacturer recommends that seal water be supplied to the new seal. The seals on the three larger pumps (Pumps #3, #4, and #5) have recently been replaced with new mechanical seals that do not require seal water. The seal water system is old and degraded. Additionally, the seal water pumps and suction tanks are located in the electrical room, creating a hazard to the electrical equipment.

Figure 4: Seal Water System

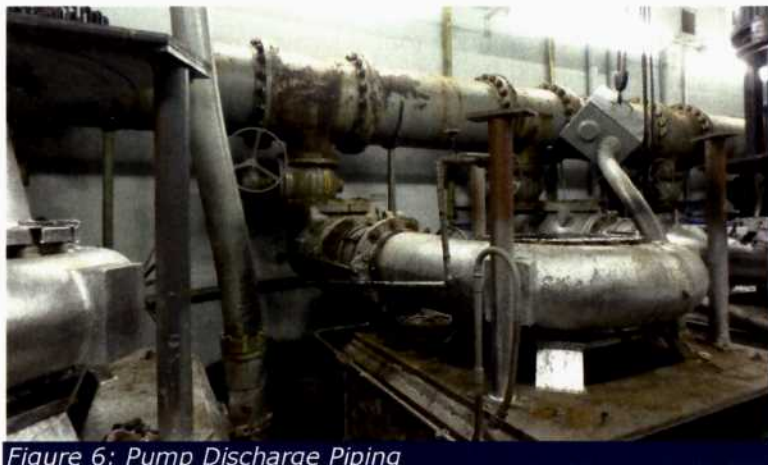
The plug valve on the discharge side of Pump #1 has failed in the closed position. A few of the check valves have broken lever arms as well. Replacing the pump isolation plug valves is currently not possible because there is no way to isolate the Lift Station piping from the rest of the downstream force main.

Figure 6: Pump Discharge Piping

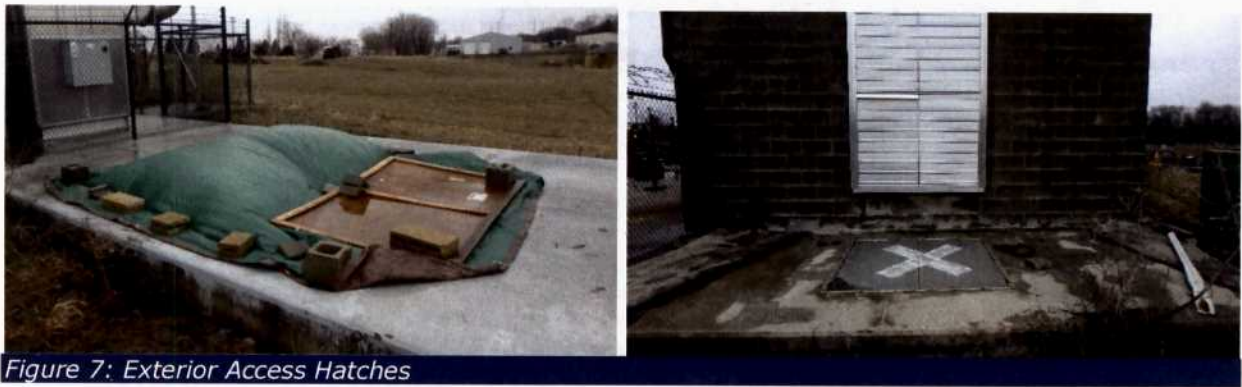
A removable section of concrete slab is located in the roof of the headworks chamber for access to the grinder. Seepage around the slab has caused deterioration to the insulation on the interior ceiling of the lift station. Currently, a tarp has been placed over the slab in order to reduce seepage. Another access hatch is located on the East side of the lift station above the electrical room. A waterproofing membrane was previously installed on the slab surrounding the hatch. That membrane was damaged and currently sits in bundles on top of the slab, creating areas of water retention. Inside the electrical room, there are signs of water leakage through the existing access hatch.

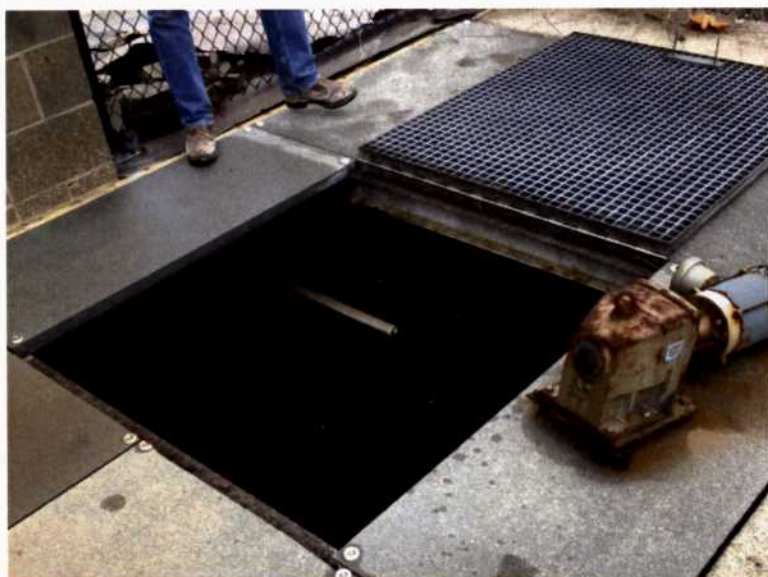
The main access into the wet well is through hinged fiberglass panels. The steel support beams for the fiberglass panels show signs of corrosion. Additionally, one of the access openings is located immediately outside the door to the generator room, a significant safety concern.

*Figure 8: Wet Well Access Panels*

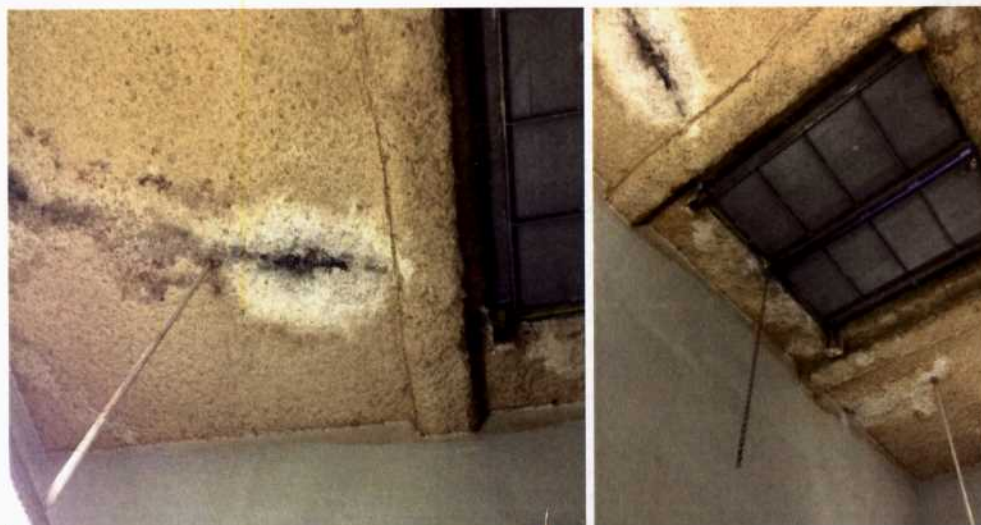
The ceiling insulation in the electrical room exhibits signs of moisture retention and molding. The existing insulation should be removed and replaced. The hatch above the electrical room is not sealed, causing leakage. The hatch should be replaced to prevent further water damage.

*Figure 9: Electrical Room Ceiling*

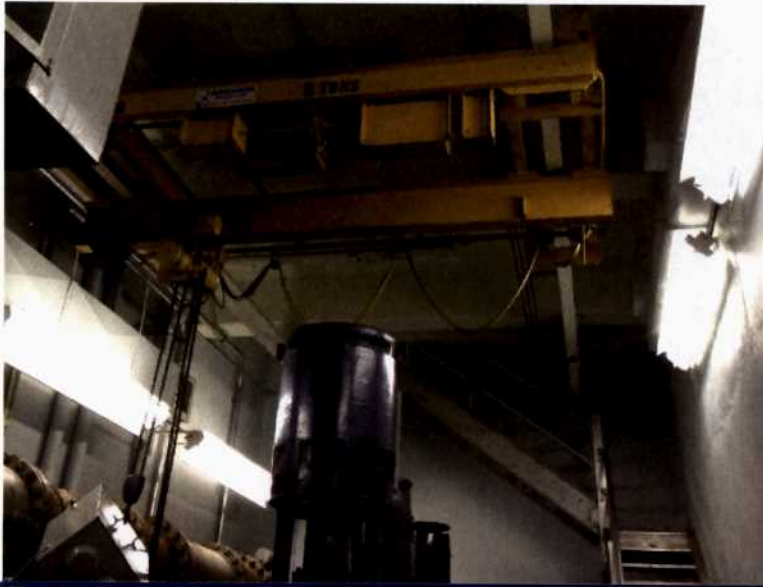
An overhead crane is located in the pump room for removal and reinstallation of equipment. The posted rating of the crane is two (2) tons, or 4,000 pounds. Equipment weights were not verified but the crane capacity is assumed to be adequate. The support beams for the crane show signs of spalling paint.

Figure 10: Existing Overhead Crane

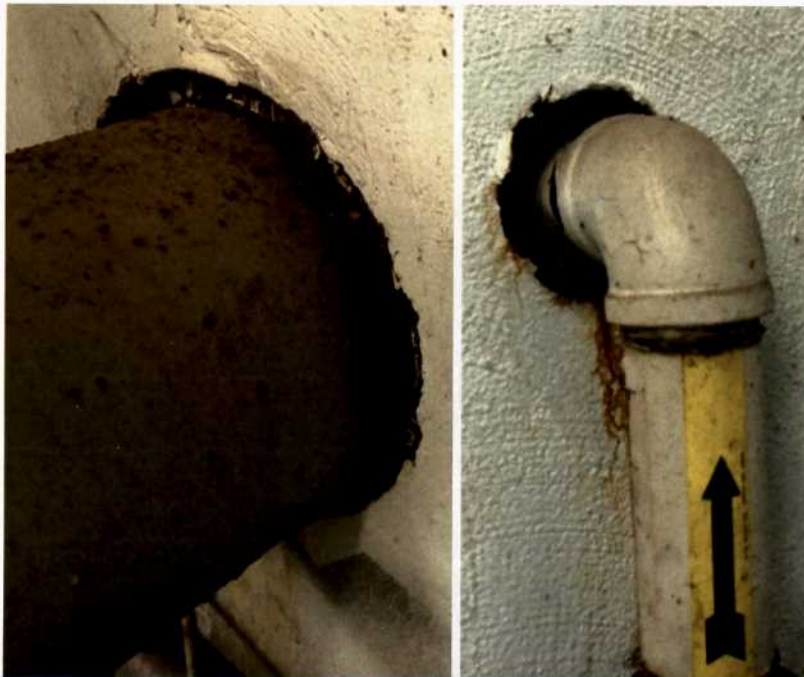
The existing pipe penetration seals between the drywell and wetwell are significantly corroded. These seals are critical for keeping wastewater and sewer gasses from entering the drywell.

Figure 11: Drywell Pipe Penetration Seals

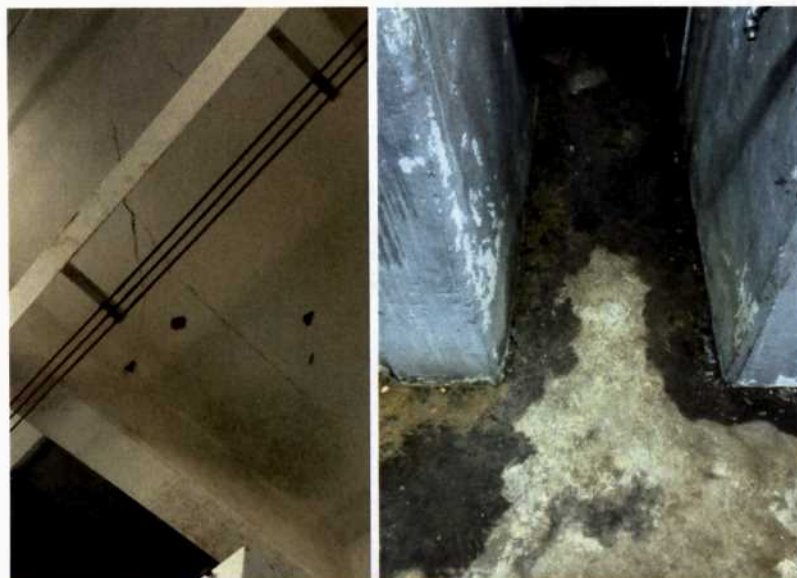
The concrete slab that composes the ceiling of the pump room contains cracking. These cracks may exacerbate moisture conditions and should be repaired. The floor slab in the pump room shows significant deterioration due to standing water.

*Figure 12: Pump Room Ceiling Cracking and Floor Slab*

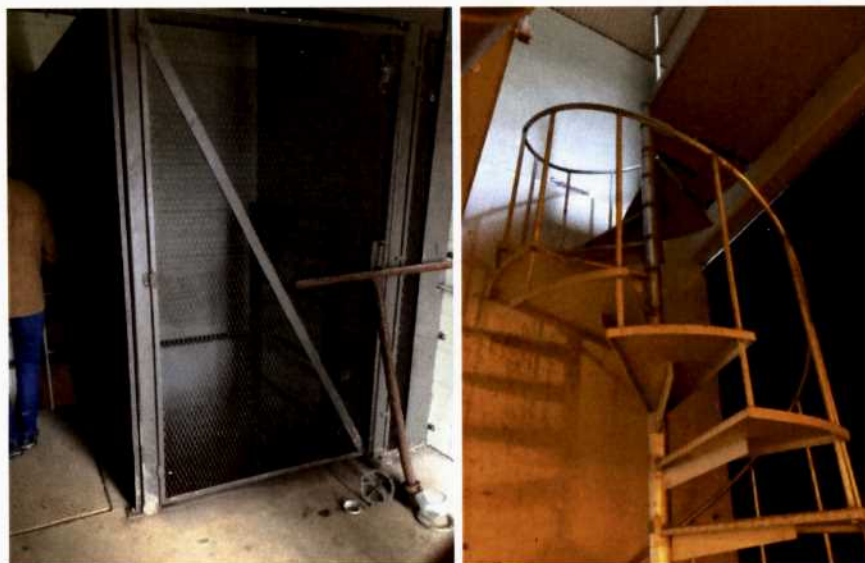
There is an existing elevator that was used to remove the screening dumpster when the mechanical bar screen was in service. The elevator has stopped functioning and without the screening system it has limited usefulness. Adjacent to the elevator is a metal spiral staircase. The tight curvature of the spiral staircase makes it difficult for materials to be carried into the headworks chamber. City Operators have indicated a preference for both the elevator and spiral staircase to be replaced with a straight staircase with an intermediate landing, similar to the stairway into the pump room.

*Figure 13: Elevator and Spiral Staircase*

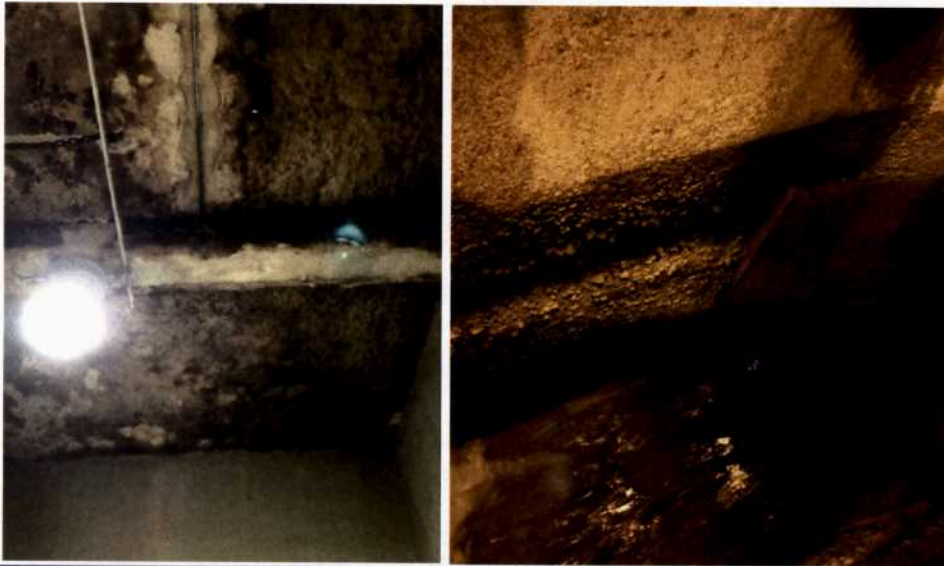
The concrete channel walls are pitted and spalled, likely due to hydrogen sulfide gases. Continued erosion of the walls could affect the function of the channel. The walls need to be repaired.

*Figure 14: Headworks Chamber Ceiling and Channel concrete spalling*

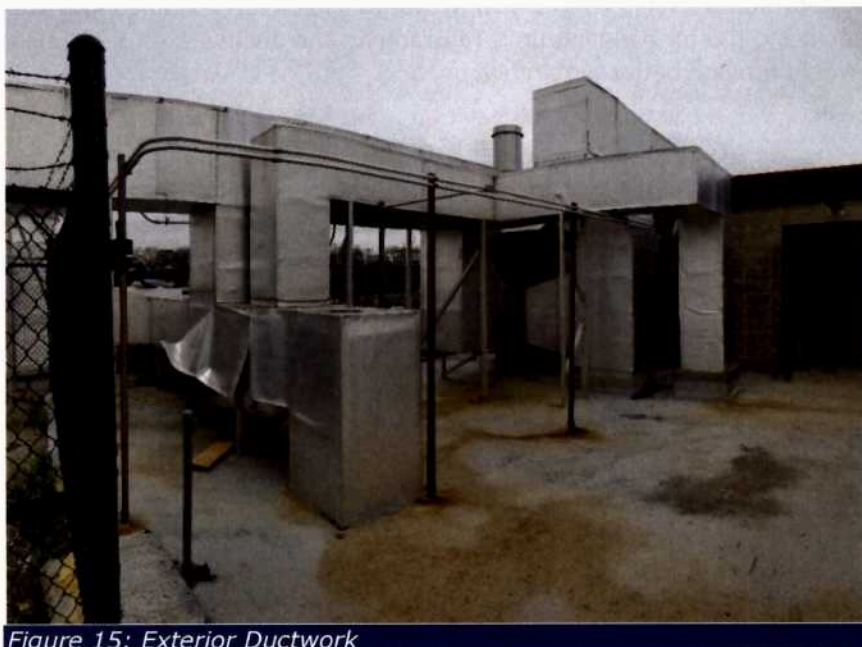
The ductwork wrapping on all exterior ductwork is peeling off and in some locations barely attached to the duct. The dampers and actuators associated with the odor control system are rusted through and unusable. The make-up air unit is missing a handle on the shut off panel.

Figure 15: Exterior Ductwork

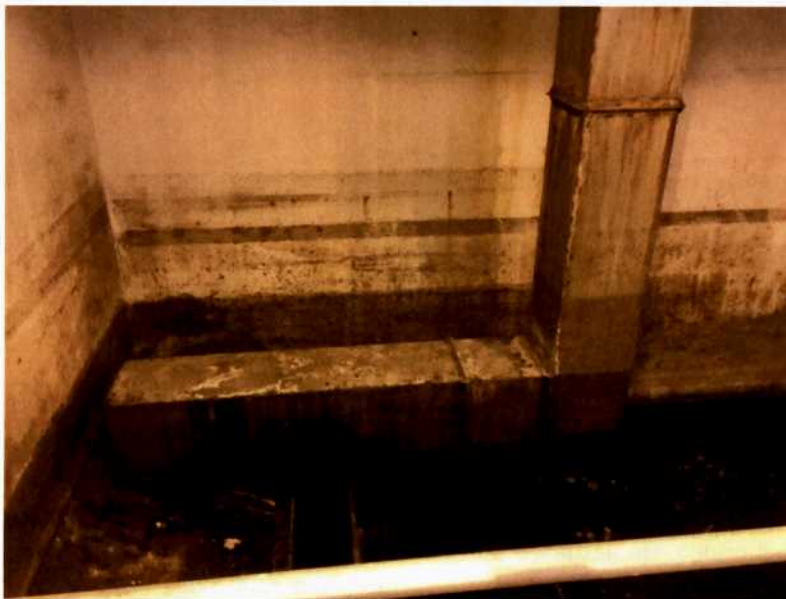
Per NFPA 820, spaces like the headworks chamber with open wastewater channels are classified as Class 1, Division 1; unless ventilation is provided at 12 air changes per hour. If adequate ventilation is provided, the classification is reduced to Class 1, Division 2, and the requirements for explosion protection are reduced. Based on the documentation provided by the City on the existing air handling unit, adequate ventilation is being provided to reduce the classification in the headworks chamber.

*Figure 16: Headworks Chamber Exhaust Hood and Duct*

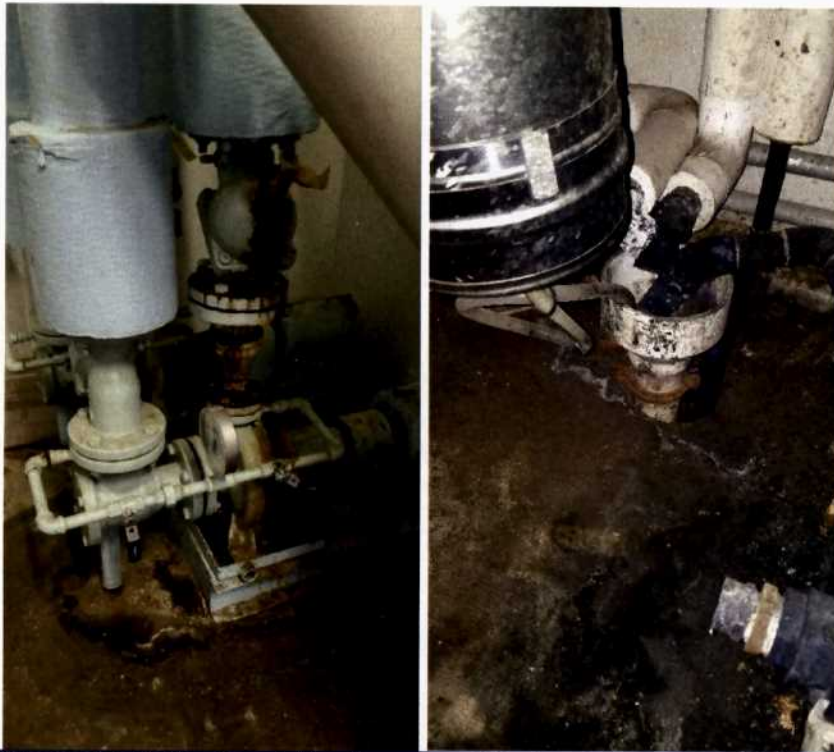
The boiler drain is crowded and needs to be relocated outside of the generator room. The drain pipe passes through the floor slab into the electrical room below and is routed above electrical equipment, creating a potential hazard.

*Figure 17: Boiler Circulation Pumps and Drain*

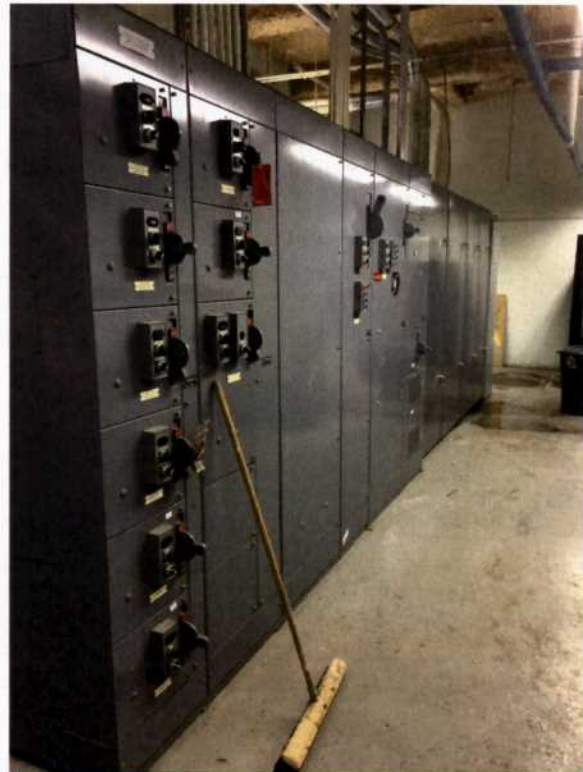
The electrical room has likely been exposed to corrosive gases such as hydrogen sulfide. Corrosive gas exposure is likely responsible for the premature VFD failure and corrosion of soft metals in the MCC. Copper and aluminum are soft metals commonly used as conductors and used within circuit boards. Exposure to corrosive gasses has likely shortened the life of electrical components in the electrical room. Additionally, water lines, water tanks, and water pumps are located in the electrical room, creating a significant potential risk to the electrical equipment.

Figure 18: Existing Motor Control Center

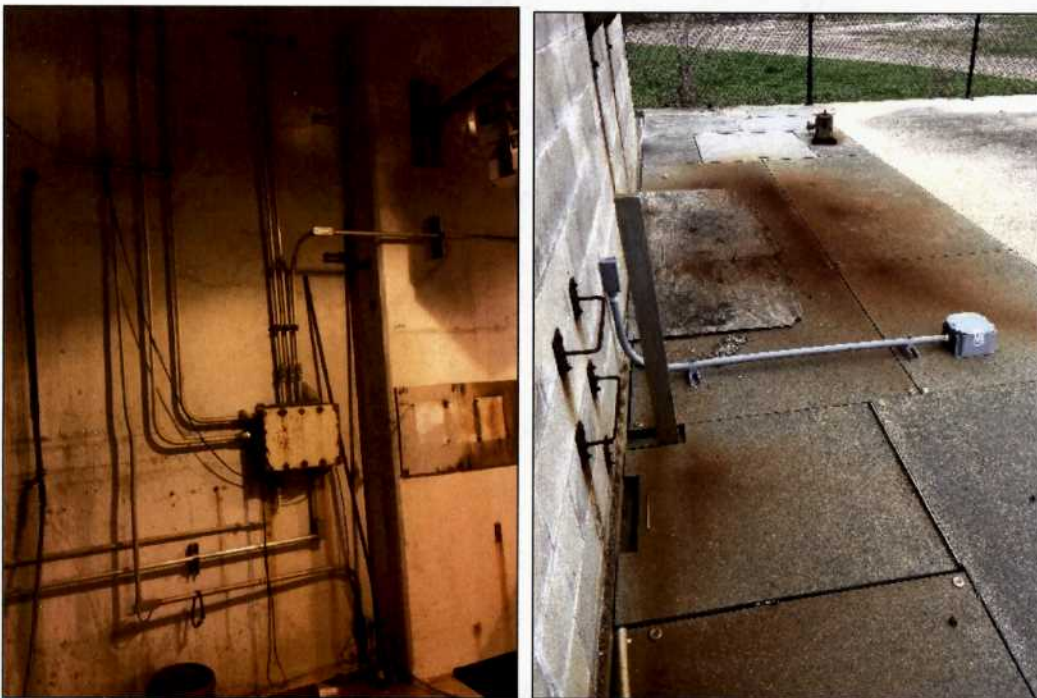
The Wet Well is a Class 1, Division 1 rated space. A PVC conduit is installed through the top of the wet well and runs back to the pump station control panel. The conduit is required to be explosion proof since it penetrates the wet well which is a hazardous space. There are also various unused conduits and conductors visible inside the wet well, penetrating the wet well top slab, and penetrating the north wall of the wet well into the electrical and pump rooms. Unused conduits should be removed, penetrations properly sealed, and conduits that are to remain must be explosion proof.

*Figure 21: Main junction box in Headworks Chamber and Conduit Penetration into Wet Well*

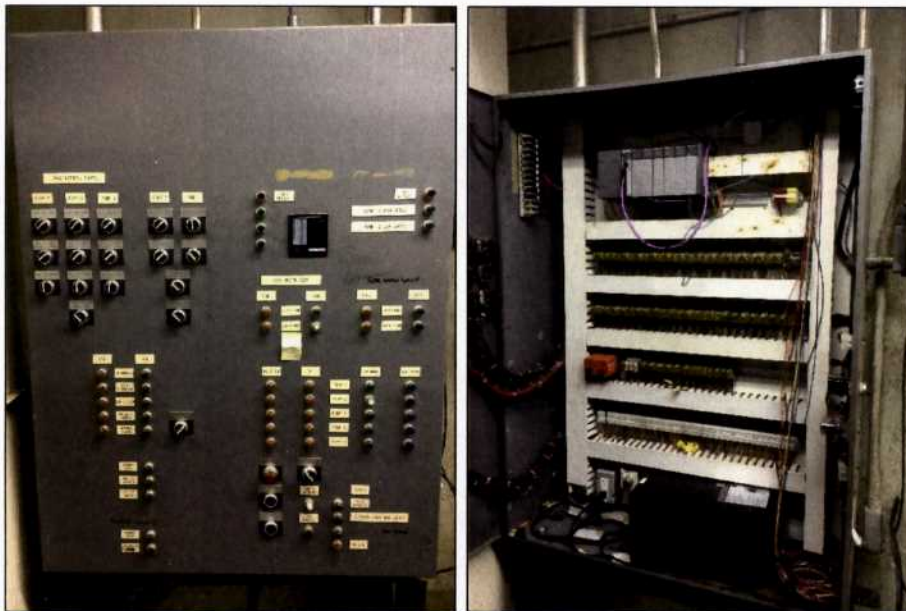
A drain line is installed through the floor above the control panel, and water has infiltrated the control panel in the past causing damage. Overall the main control panel, components, and wiring are in poor condition and have reached end of life.

Figure 22: Pump Control System Panel

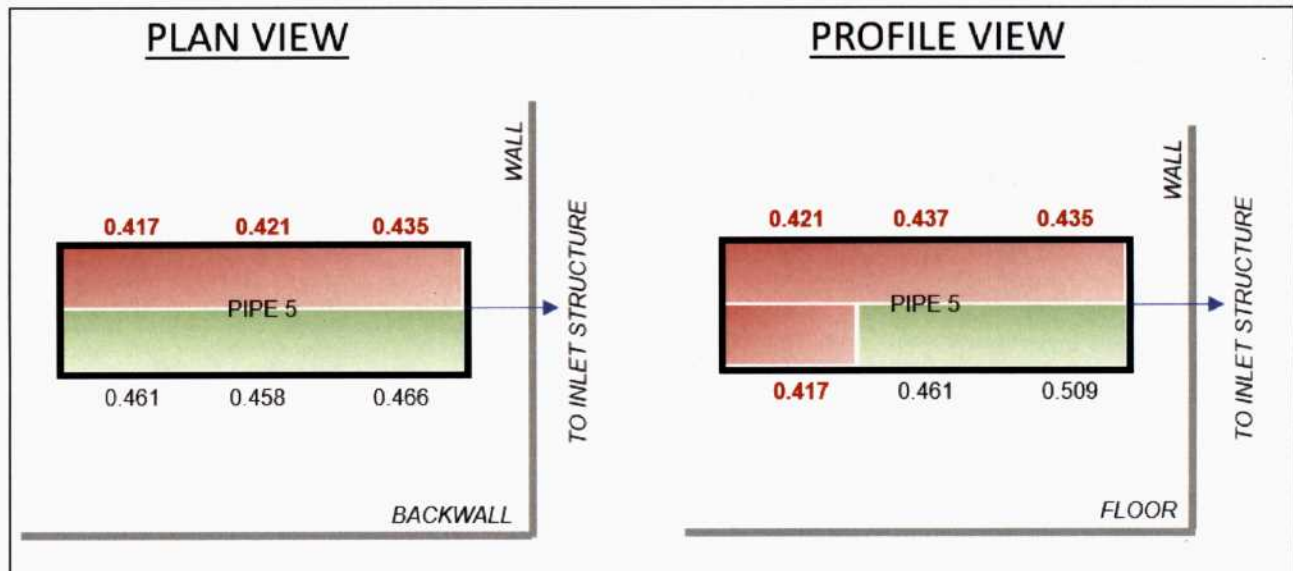
**Figure 6:** Thickness Measurements (in inches) of "Pipe 5"
