**CITY OF STORM LAKE  
REGULAR COUNCIL MEETING, CITY HALL  
COUNCIL CHAMBERS  
MARCH 2, 2020  
5:00 PM**

- 8. **Public Hearing for Submission of an Application for a Community Development Block Grant - Memorial Lift Station**
- 9. **Resolution No. 55-R-2019-2020 Committing Matching Funds for a Community Development Block Grant - Memorial Lift Station**

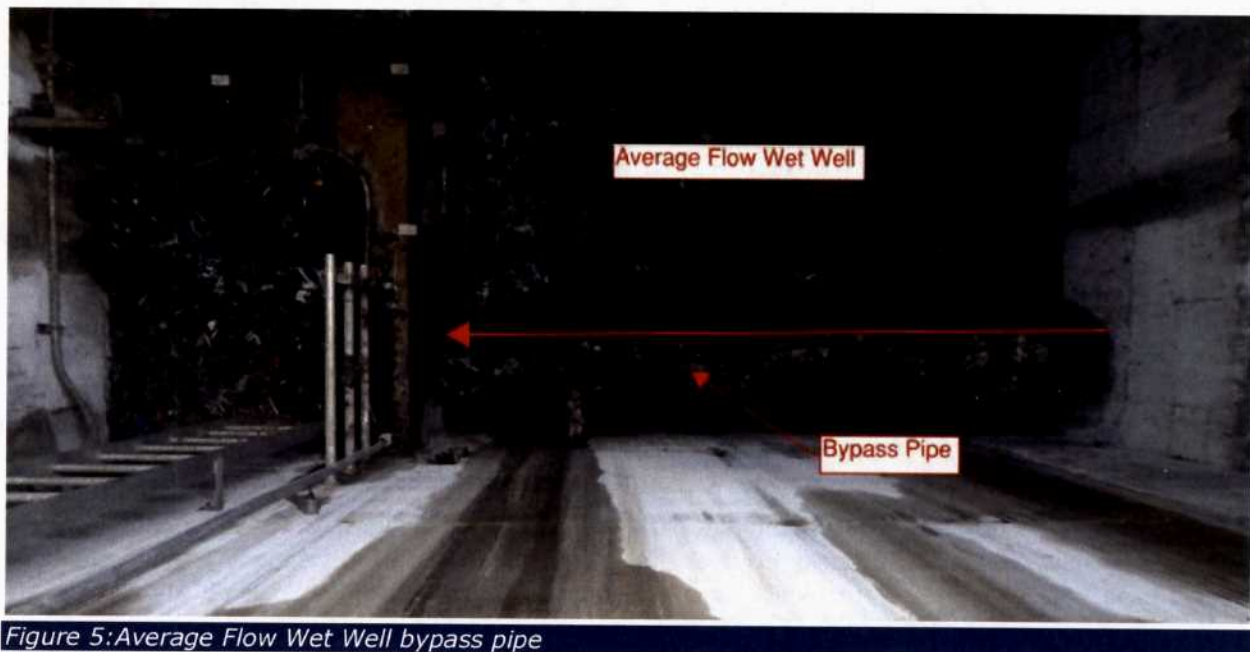
Figure 5: Average Flow Wet Well bypass pipe

While not shown on the original plans, a pipe has been installed from the influent channel to the peak flow wet well. Based on the elevation of this pipe, it is assumed that it serves to bypass flow directly to the peak flow wet well during high flow events when the 18" openings into the average flow wet well are unable to hydraulically pass the influent flows.

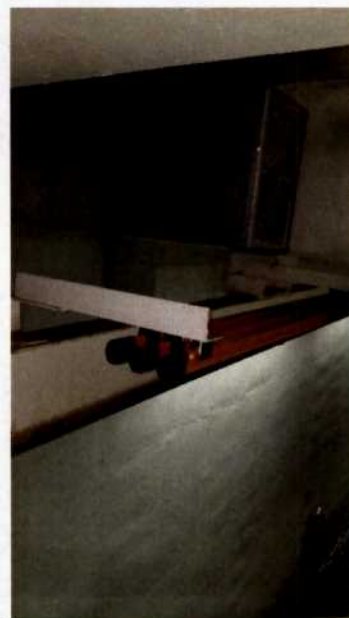
*Figure 20: Electric Hoist Bus Bar near stair handrail*

An electric hoist is located in the pump room for equipment removal. The hoist is powered by a 480 volt open bus bar running across the ceiling. The open bus bar is very close to the stair handrail, and can be reached from the stairwell. This is a significant electric shock hazard and a barrier should be installed to prevent accidental contact with the bus bar. The bus bar disconnect is also in poor condition.

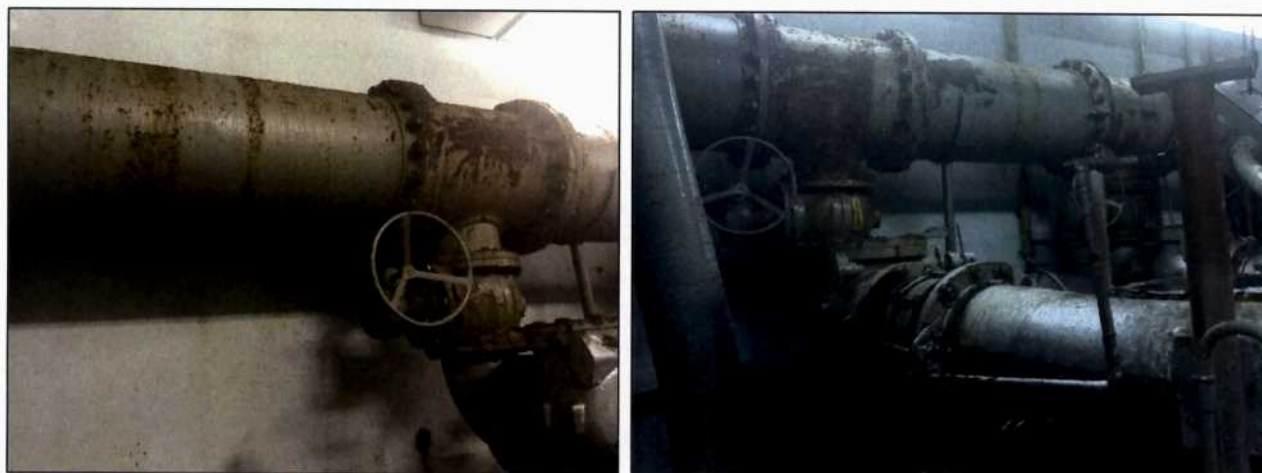
**Figures 1 and 2:** Exterior of the Lift Station Header Piping

The lift station header piping was originally installed in 1983 and has been in continuous use since its construction. The exterior of the DIP piping has noticeable areas of corrosion and chipped paint (see **Figures 1 and 2**). Replacing this piping would require bypass pumping around the entire lift station, which would add significant cost. Therefore, the City of Storm Lake contracted Pure Technologies to collect thickness measurements of the header piping in order to verify the condition of the wall of the pipe, potentially allowing it to remain in place. UTT, an ultrasonic inspection technology, was chosen in order to externally verify the wall thickness of the header piping.

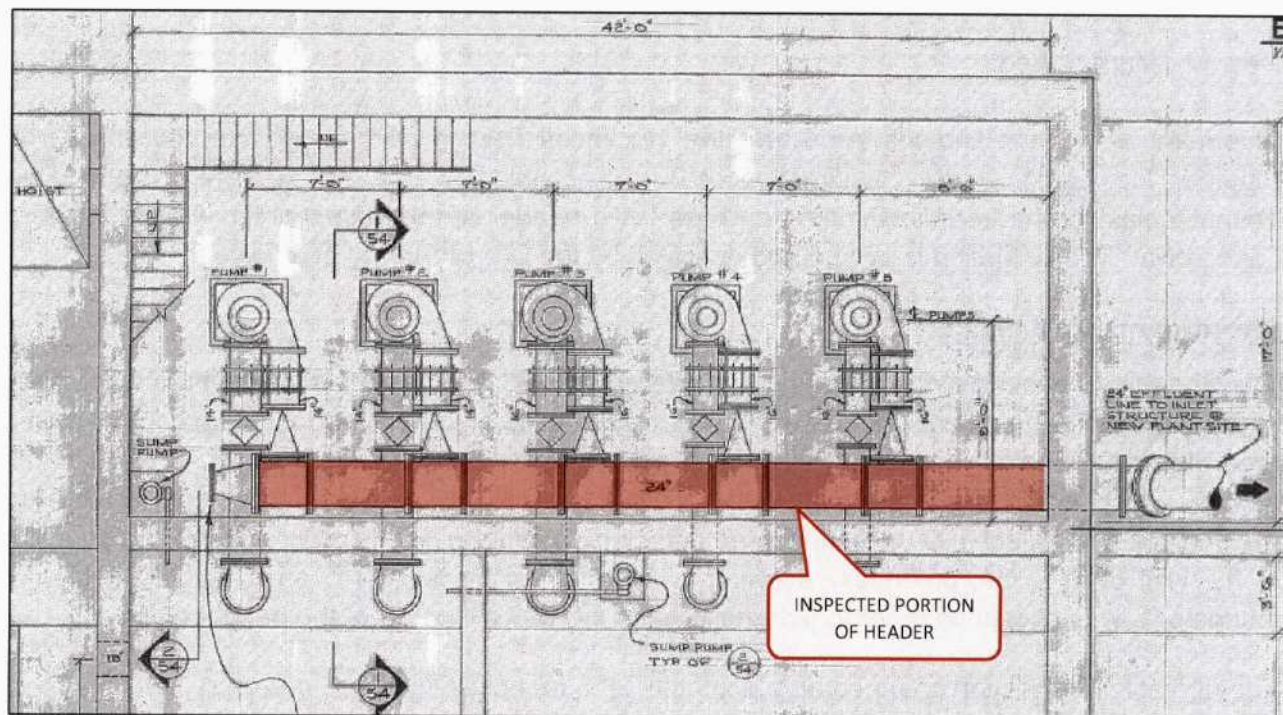
**Figure 3:** 24-inch DIP Lift Station Header

The ultrasonic inspection spanned approximately 36.5 feet of 24-inch DIP pipe and five (5) 24-inch DIP tees (see **Figure 3**). Due to lack of specifications, it was assumed that the 24-inch DIP pipe was Class 52 and the 24-inch DIP tees were Pressure Class 250. It is Pure Technologies understanding that no pressure gauges are installed on the header piping in order to collect direct pressure readings at operating conditions. However, it was determined that a pressure relief valve exists on the header which is set to open at 65 psi. Assuming the valve is in good operating condition, 65 psi would be the maximum operating pressure for the header. These assumptions are important when comparing the measured thicknesses to the design thickness. If the City of Storm Lake finds any additional details or specifications for the lift station header piping, Pure Technologies can compare the updated design thickness with the measured thickness for a more accurate analysis.

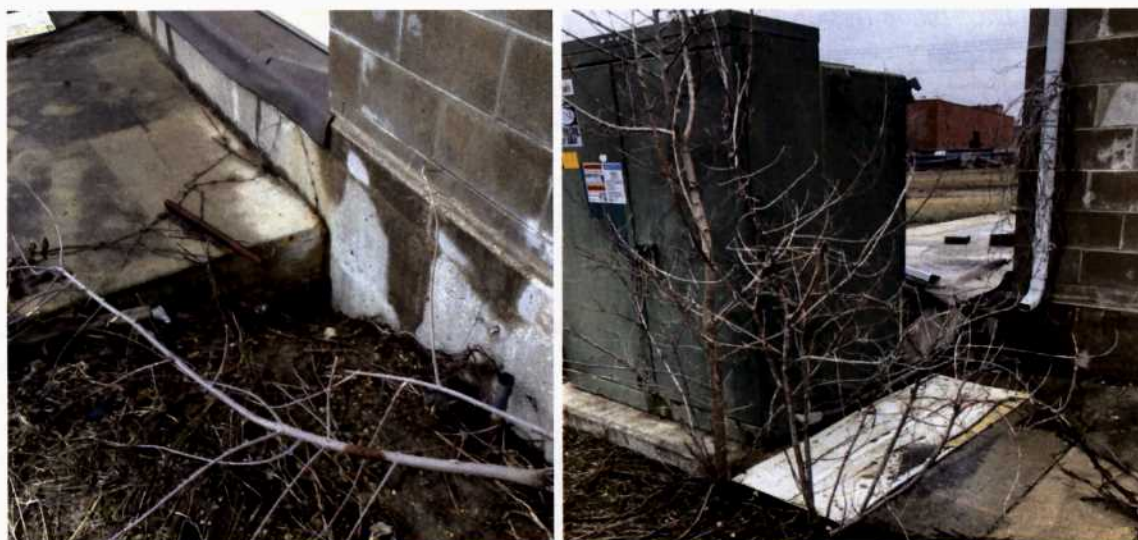
*Figure 2: Animal Burrows, downspouts, and vegetation around lift station exterior*

Around the exterior of the lift station, animals have burrowed holes at several locations below stoops and the transformer pad. These holes should be filled and measures taken to prevent future unwanted excavations. Vegetation has grown up around the building slab as well, hindering maintenance access. The roof gutter downspouts are not connected to a sufficient outlet and several of them discharge directly to the ground immediately next to the lift station. This likely contributes to water accumulation and seepage into the lift station. For proper drainage, the downspouts should be directed further away from the building exterior.

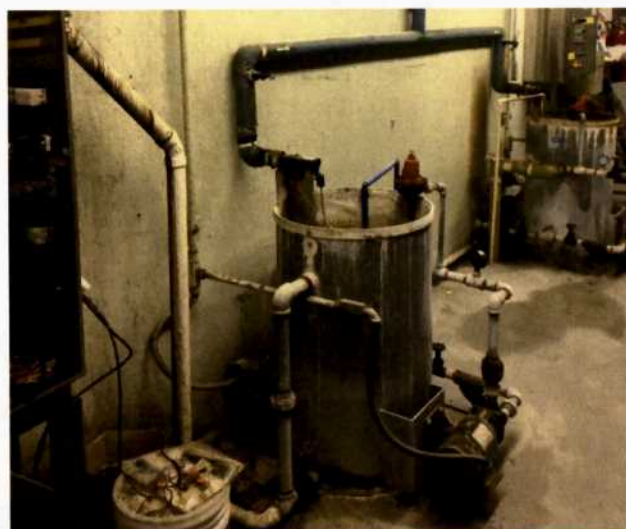
Figure 4: Seal Water System

The seal on Pump #2 was recently replaced with a new mechanical seal as well. While not required, the manufacturer recommends that seal water be supplied to the new seal. The seals on the three larger pumps (Pumps #3, #4, and #5) have recently been replaced with new mechanical seals that do not require seal water. The seal water system is old and degraded. Additionally, the seal water pumps and suction tanks are located in the electrical room, creating a hazard to the electrical equipment.

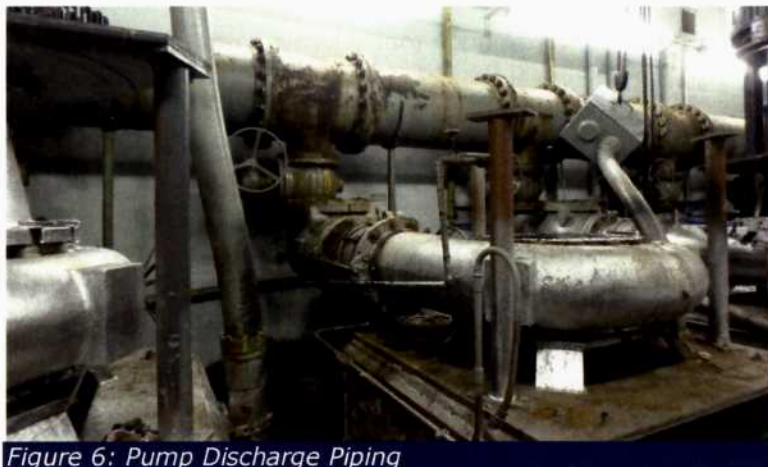
Figure 6: Pump Discharge Piping

As shown in Figure 5 below, the existing piping in the drywell has some deterioration and corrosion. A non-destructive evaluation was performed on the piping in June 2019 to determine the condition of the pipe. The evaluation determined the pipe was still in good condition. A copy of the evaluation report dated June 4, 2019 is provided in Appendix B. The pipe supports are also rusting. The base plates of the pipe supports are frequently in contact with water on the floor of the pump room.

The plug valve on the discharge side of Pump #1 has failed in the closed position. A few of the check valves have broken lever arms as well. Replacing the pump isolation plug valves is currently not possible because there is no way to isolate the Lift Station piping from the rest of the downstream force main.

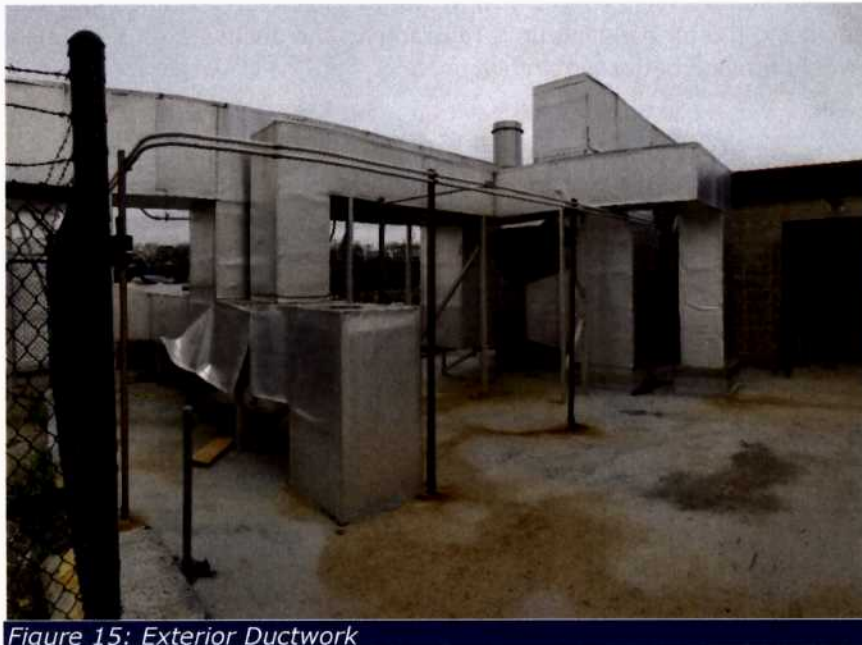
Figure 15: Exterior Ductwork

The ductwork wrapping on all exterior ductwork is peeling off and in some locations barely attached to the duct. The dampers and actuators associated with the odor control system are rusted through and unusable. The make-up air unit is missing a handle on the shut off panel.

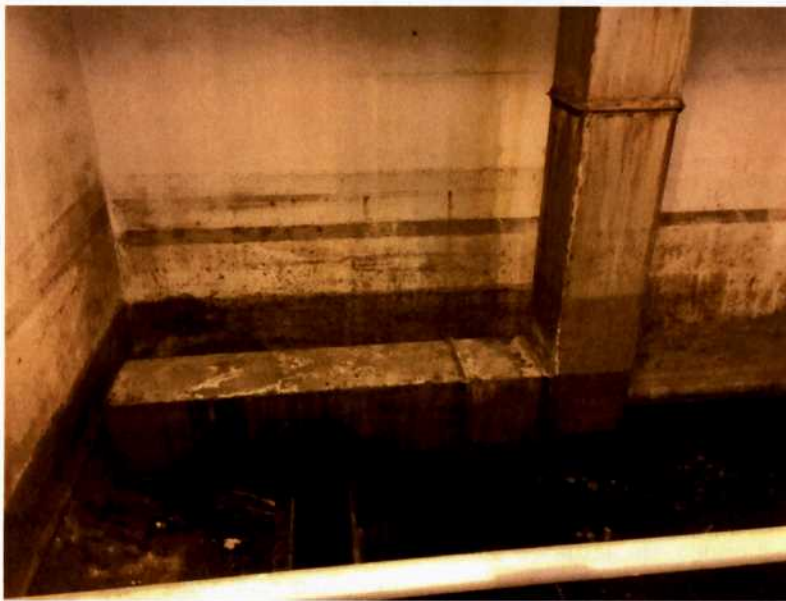
*Figure 16: Headworks Chamber Exhaust Hood and Duct*

The headworks chamber is ventilated by the large air handling unit located outside the lift station. The exhaust duct and hood over are in poor condition. The supply duct appears to be in good condition but could be cleaned, both inside and outside. The explosion proof heaters appear to be out of order. There are no dehumidification measures in the space. Dehumidifiers could help reduce moisture damage to the interior surfaces and insulation.

Per NFPA 820, spaces like the headworks chamber with open wastewater channels are classified as Class 1, Division 1; unless ventilation is provided at 12 air changes per hour. If adequate ventilation is provided, the classification is reduced to Class 1, Division 2, and the requirements for explosion protection are reduced. Based on the documentation provided by the City on the existing air handling unit, adequate ventilation is being provided to reduce the classification in the headworks chamber.

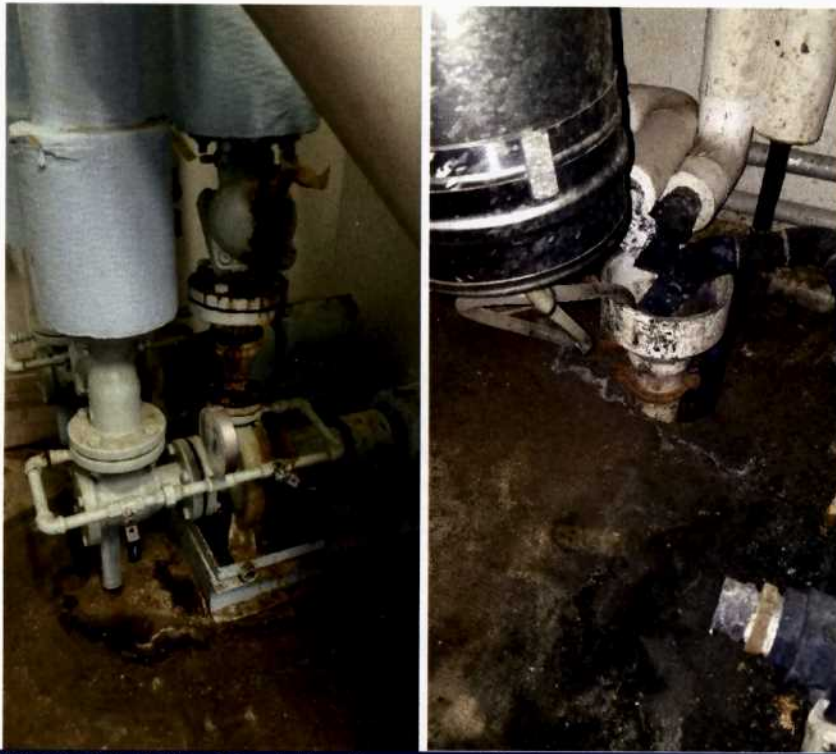
*Figure 17: Boiler Circulation Pumps and Drain*

The pumps that circulate water for the boiler show significant corrosion. They are operating at constant circulation volume without a VFD. The connected water pipes are leaking. The air separator does not appear to have a blowdown.

The boiler drain is crowded and needs to be relocated outside of the generator room. The drain pipe passes through the floor slab into the electrical room below and is routed above electrical equipment, creating a potential hazard.

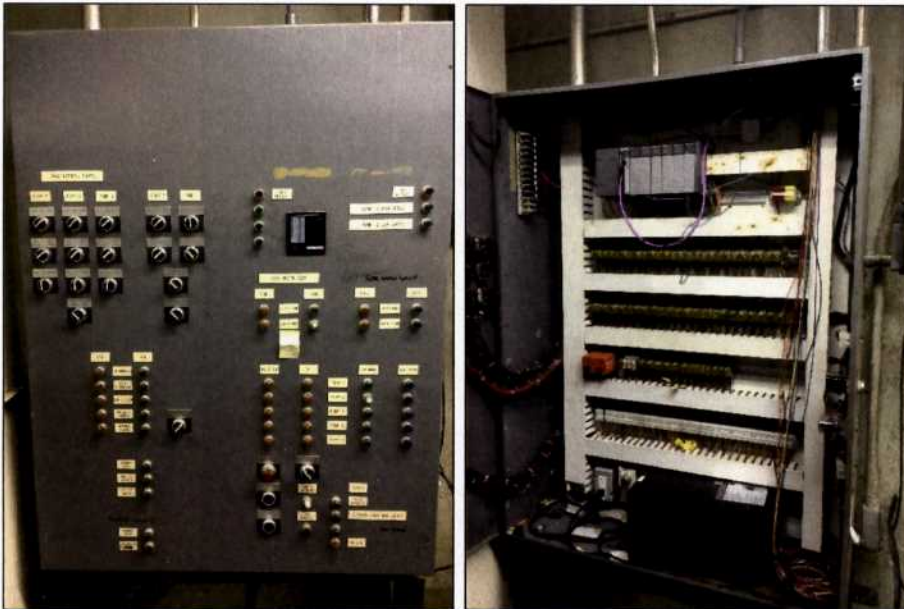
Figure 22: Pump Control System Panel

The main control panel for controlling and monitoring the pump station is located in the electrical room. An Allen Bradley SLC500 Programmable Logic Controller (PLC) system is installed. SLC500 systems are nearing end of life status from the manufacturer. Some components within this family have been discontinued. Therefore, future maintenance of the control system will be difficult. Additionally, there does not appear to be any documentation of the control system at the lift station, making it very difficult to troubleshoot any problems.

A drain line is installed through the floor above the control panel, and water has infiltrated the control panel in the past causing damage. Overall the main control panel, components, and wiring are in poor condition and have reached end of life.

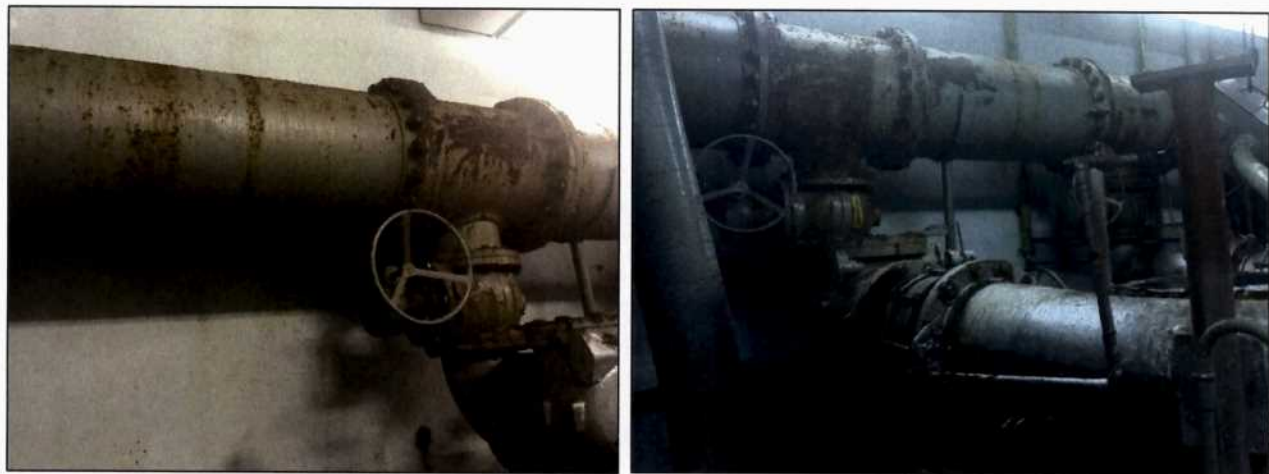
**Figures 1 and 2:** Exterior of the Lift Station Header Piping

The lift station header piping was originally installed in 1983 and has been in continuous use since its construction. The exterior of the DIP piping has noticeable areas of corrosion and chipped paint (see **Figures 1 and 2**). Replacing this piping would require bypass pumping around the entire lift station, which would add significant cost. Therefore, the City of Storm Lake contracted Pure Technologies to collect thickness measurements of the header piping in order to verify the condition of the wall of the pipe, potentially allowing it to remain in place. UTT, an ultrasonic inspection technology, was chosen in order to externally verify the wall thickness of the header piping.

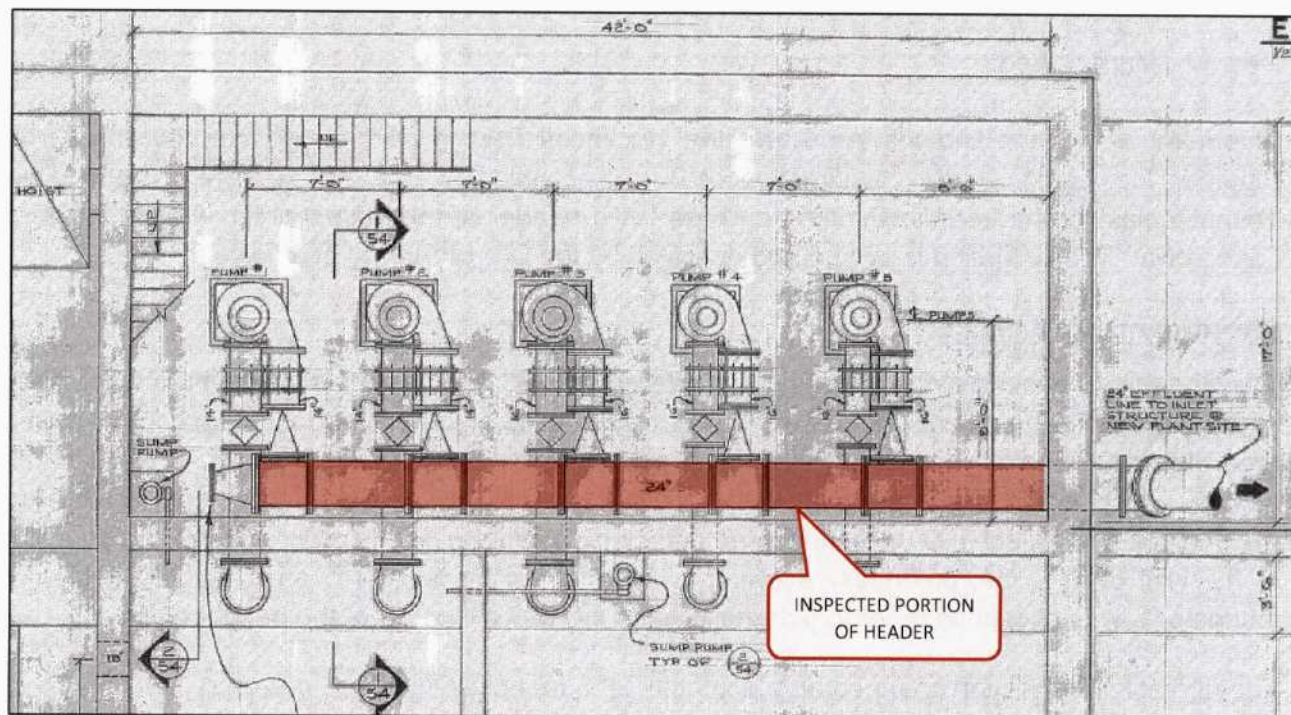
**Figure 3:** 24-inch DIP Lift Station Header

The ultrasonic inspection spanned approximately 36.5 feet of 24-inch DIP pipe and five (5) 24-inch DIP tees (see **Figure 3**). Due to lack of specifications, it was assumed that the 24-inch DIP pipe was Class 52 and the 24-inch DIP tees were Pressure Class 250. It is Pure Technologies understanding that no pressure gauges are installed on the header piping in order to collect direct pressure readings at operating conditions. However, it was determined that a pressure relief valve exists on the header which is set to open at 65 psi. Assuming the valve is in good operating condition, 65 psi would be the maximum operating pressure for the header. These assumptions are important when comparing the measured thicknesses to the design thickness. If the City of Storm Lake finds any additional details or specifications for the lift station header piping, Pure Technologies can compare the updated design thickness with the measured thickness for a more accurate analysis.

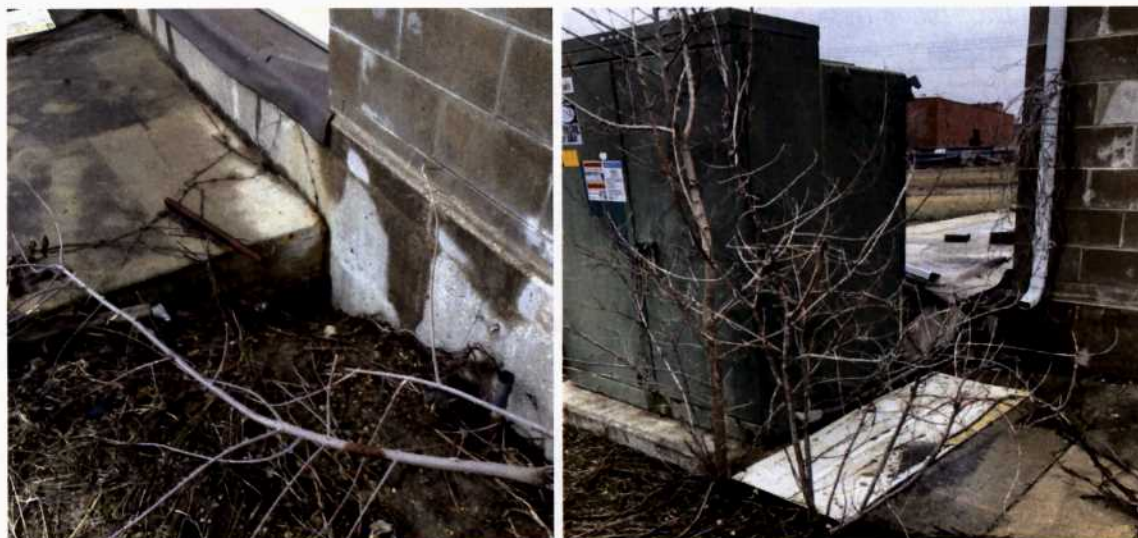
*Figure 2: Animal Burrows, downspouts, and vegetation around lift station exterior*

Around the exterior of the lift station, animals have burrowed holes at several locations below stoops and the transformer pad. These holes should be filled and measures taken to prevent future unwanted excavations. Vegetation has grown up around the building slab as well, hindering maintenance access. The roof gutter downspouts are not connected to a sufficient outlet and several of them discharge directly to the ground immediately next to the lift station. This likely contributes to water accumulation and seepage into the lift station. For proper drainage, the downspouts should be directed further away from the building exterior.

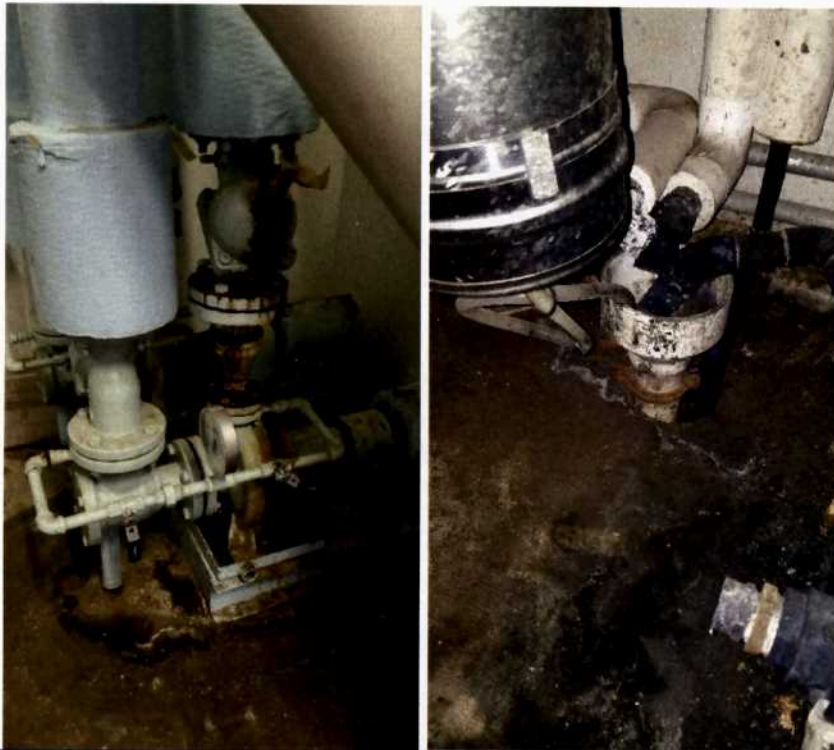
*Figure 17: Boiler Circulation Pumps and Drain*

The pumps that circulate water for the boiler show significant corrosion. They are operating at constant circulation volume without a VFD. The connected water pipes are leaking. The air separator does not appear to have a blowdown.

The boiler drain is crowded and needs to be relocated outside of the generator room. The drain pipe passes through the floor slab into the electrical room below and is routed above electrical equipment, creating a potential hazard.

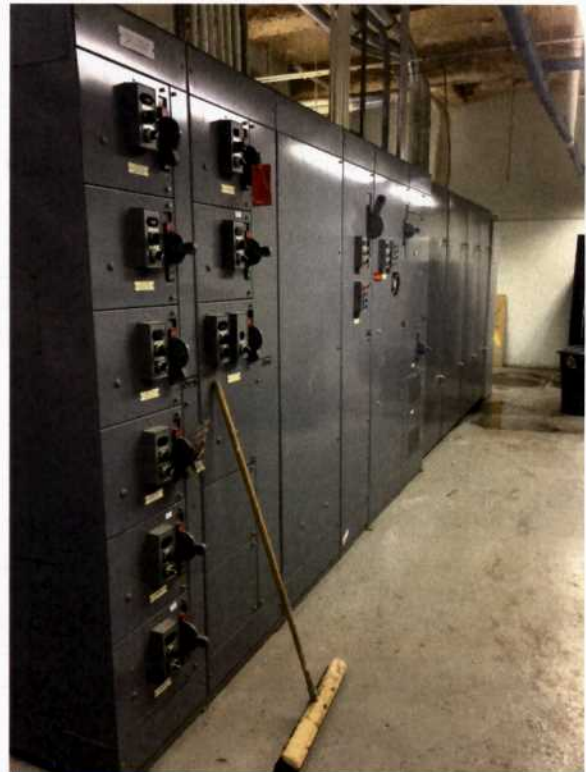
Figure 18: Existing Motor Control Center

Considerable corrosion was noted on the MCC and related electrical equipment. None of the MCC sections are installed on housekeeping pads, and corrosion is present at the base of several MCC sections. Foul odor was observed in the electrical room due to the lack of outside air ventilation. City staff indicated a variable speed drive had previously been installed in the MCC to serve pump #5, but had since failed. The VFD was subsequently replaced with a soft starter.

The electrical room has likely been exposed to corrosive gases such as hydrogen sulfide. Corrosive gas exposure is likely responsible for the premature VFD failure and corrosion of soft metals in the MCC. Copper and aluminum are soft metals commonly used as conductors and used within circuit boards. Exposure to corrosive gasses has likely shortened the life of electrical components in the electrical room. Additionally, water lines, water tanks, and water pumps are located in the electrical room, creating a significant potential risk to the electrical equipment.

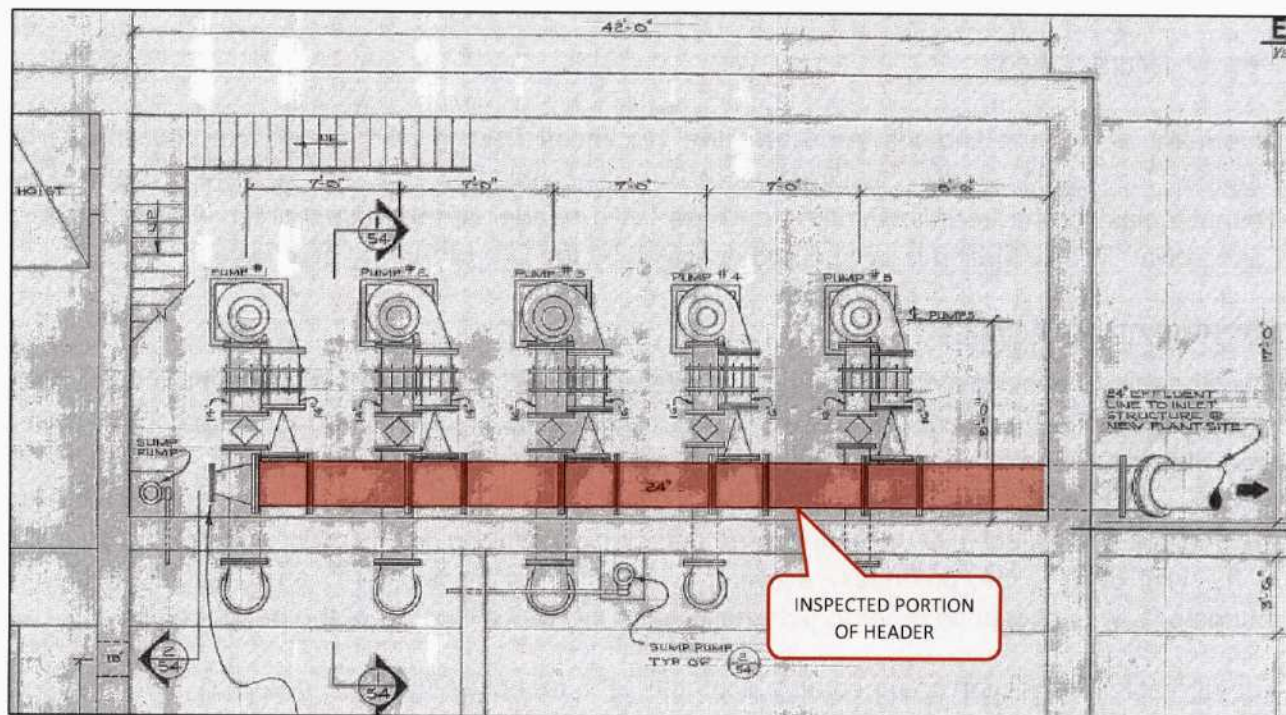
**Figure 3:** 24-inch DIP Lift Station Header

The ultrasonic inspection spanned approximately 36.5 feet of 24-inch DIP pipe and five (5) 24-inch DIP tees (see **Figure 3**). Due to lack of specifications, it was assumed that the 24-inch DIP pipe was Class 52 and the 24-inch DIP tees were Pressure Class 250. It is Pure Technologies understanding that no pressure gauges are installed on the header piping in order to collect direct pressure readings at operating conditions. However, it was determined that a pressure relief valve exists on the header which is set to open at 65 psi. Assuming the valve is in good operating condition, 65 psi would be the maximum operating pressure for the header. These assumptions are important when comparing the measured thicknesses to the design thickness. If the City of Storm Lake finds any additional details or specifications for the lift station header piping, Pure Technologies can compare the updated design thickness with the measured thickness for a more accurate analysis.

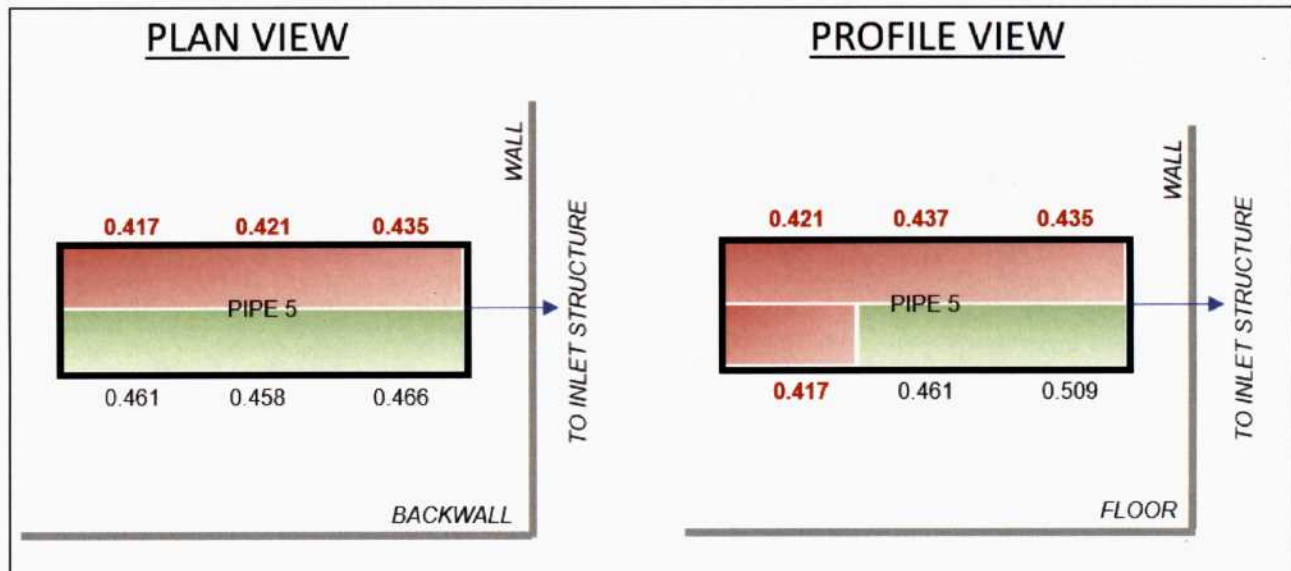
**Figure 6:** Thickness Measurements (in inches) of "Pipe 5"

measurements "P1" and "P10" at 0.417 inches. A diagram indicating the measurements taken for "Pipe 5" is shown in **Figure 6**.

Though it is possible that wall loss may have occurred at this location, a wall thickness measurement of 0.417 inches (the minimum observed) for 24-inch DIP corresponds with a design pressure class of 300 pounds per square inch (psi)<sup>1</sup>. This pressure class is defined as the rated water pressure of the pipe in psi. Therefore, if the City of Storm Lake is operating the header piping under 300 psi, it can be assumed that the header piping is in serviceable condition.

It is Pure Technologies understanding that no pressure gauges are installed on the header piping in order to collect direct pressure readings at operating conditions. However, it was determined that a pressure relief valve exists on the header which is set to open at 65 psi. Assuming the valve is in good operating condition, 65 psi would be the maximum operating pressure for the header.
